MISCELLANEOUS PAPER NO. 6-760

SONISCOPE SURVEY, PAD 39-A CAPE KENNEDY, FLORIDA

H. T. Thornton, Jr.

November 1965

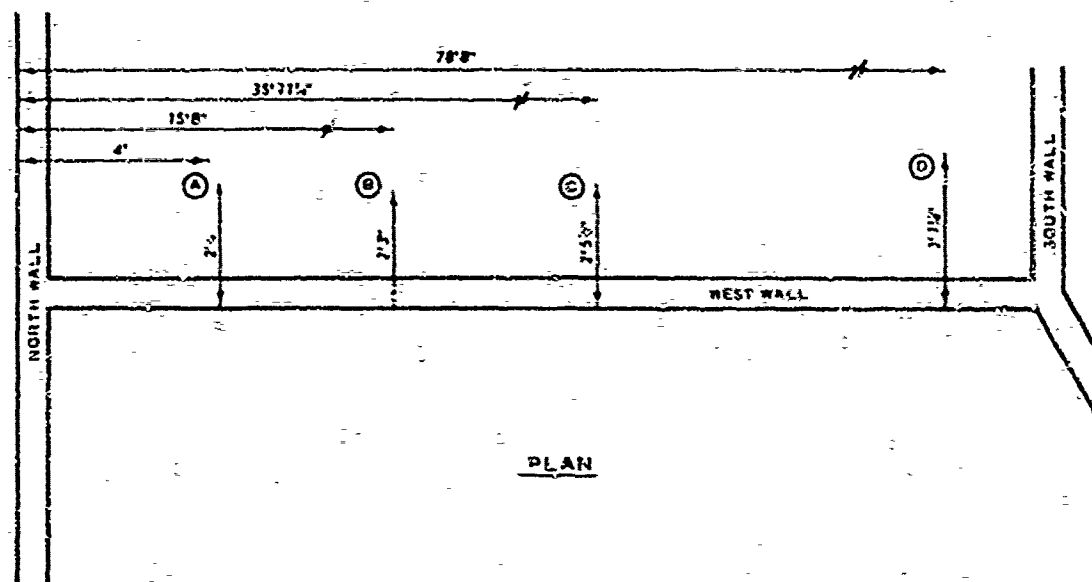
Fig. 1. Station locations on roof of ECS building

6. Roof adjacent to west wall of ECS building. Fill dirt was excavated from the roof at four sites adjacent to the west wall. Stations A, B, C, and D were located on the topside of the roof, one at each of the four excavated sites. Stations bearing the same letters (A, B, C, and D) were then located on the underside of the roof directly beneath the four stations on the top. From each of these stations on the underside of the roof, an array of points was established and numbered for the purpose of exploring the surrounding concrete with a series of diagonal measurements from the station on top to the station and points underneath. Fig. 1 shows the location of the four stations on the

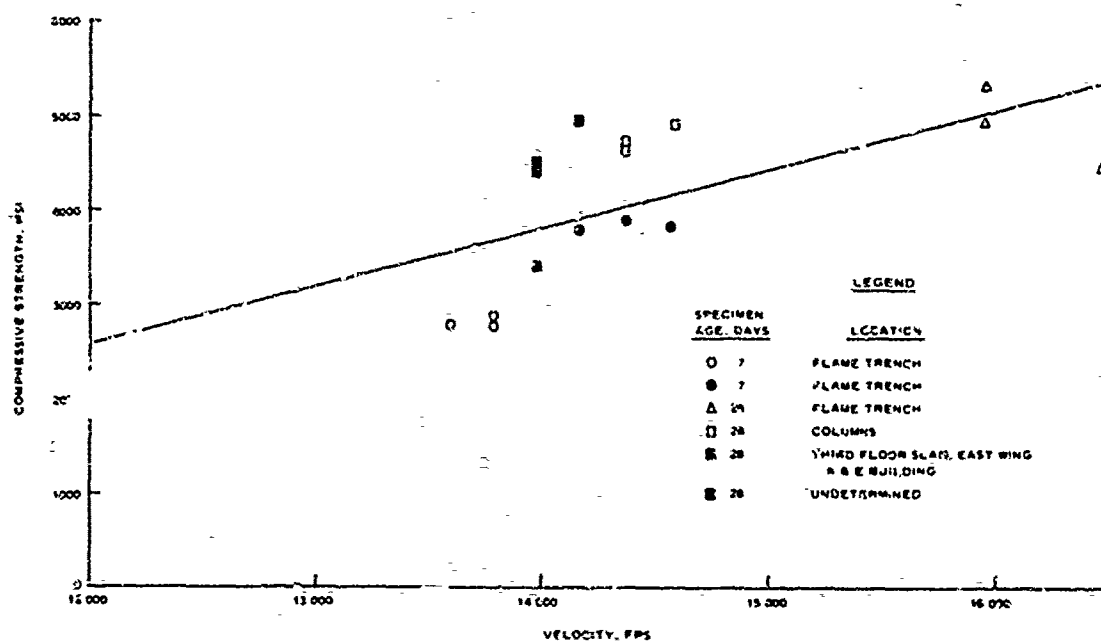
Fig. 2. Compressive strength versus velocity for 6- by 12-in. cylinders.

Using the data given in the preceding tabulation, a plot of compressive strength versus pulse velocity was made and the least-squares straight line was calculated (fig. 2).

9. Results obtained from the compressive strength-pulse velocity tests performed on the 6- by 12-in. cylinders which were made from a concrete mixture comparable to that used in pad 39-A indicate that a velocity of 14,000 fps represents a compressive strength of at least 3000 psi.

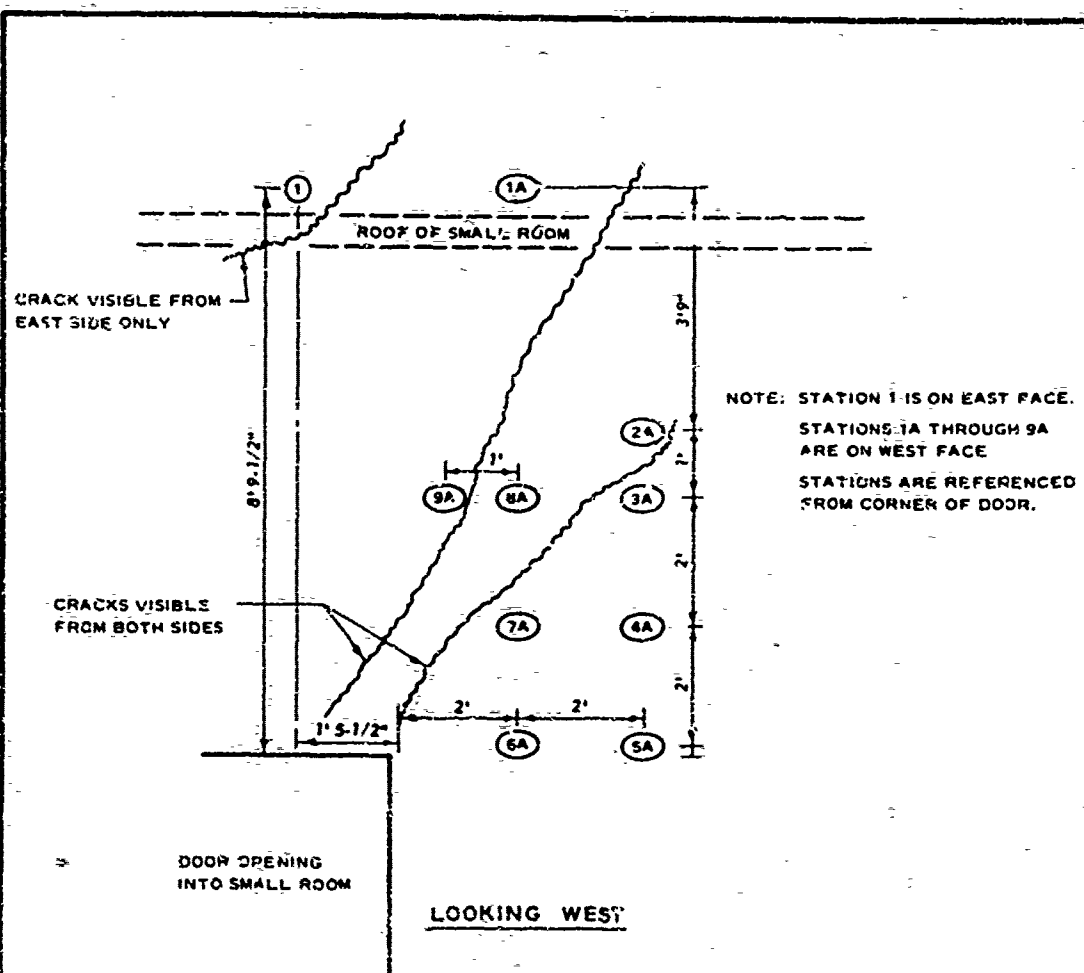
PLATE 1

- a. North end near ceiling. All readings in this area were taken diagonally through the wall from station 1 (plate 1) on the east face to stations located on the west face of the wall. The path of each reading passed through concrete in which damage by cracking was apparent. One measurement which produced a velocity of 15,245 fps seemed to be affected very little by the one crack in its path. However, the other eight readings in this area ranged between 12,030 fps and "too poor to read," thus showing the drastic effect that cracking can have on pulse velocity. Results of tests in this area are given in plate 1.

STATION LOCATION AND
PULSE VELOCITY DATA,
NORTH END OF WEST WALL
ECS BUILDING

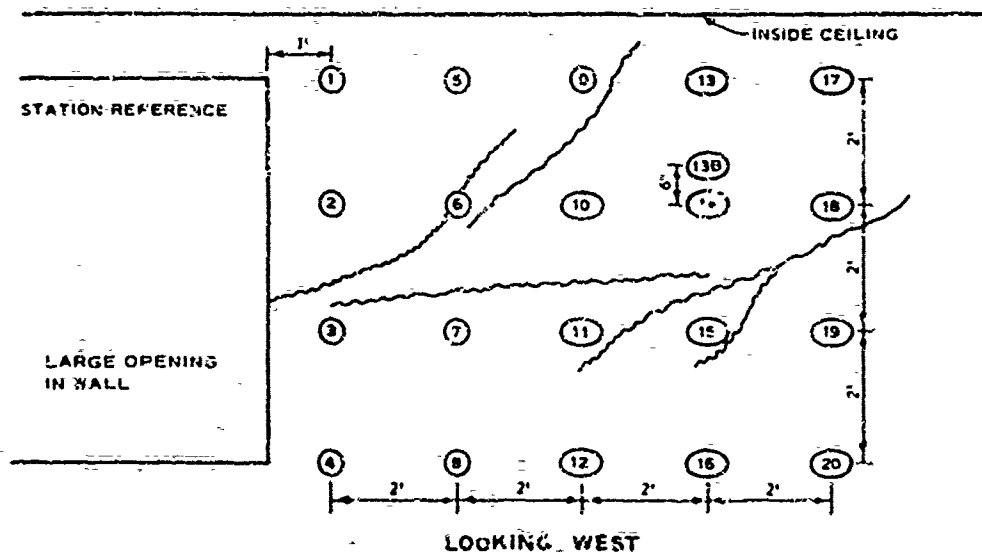
- b. Just south of area discussed above. A total of 36 measurements were taken in this area (plate 2). Six of these were taken straight through the wall, and 30 were taken diagonally from stations on the west face to stations on the east face. The six straight-through readings averaged 15,400 fps. Most of the diagonal readings were taken through cracked areas and consequently showed velocities below 15,400 fps. However, since only six velocities were below 13,000 fps and the lowest of these was 10,295 fps, the effect of cracking on velocity in this area does not seem to be drastic. Three of the stations on the west face of the wall were located in patched areas, but the patches seemed to have very little, if any, effect on velocities. Results of tests in this area are given in plate 2.

STATION LOCATION AND
PULSE VELOCITY DATA,
WEST WALL JUST SOUTH
OF AREA IN PLATE I
ECS BUILDING

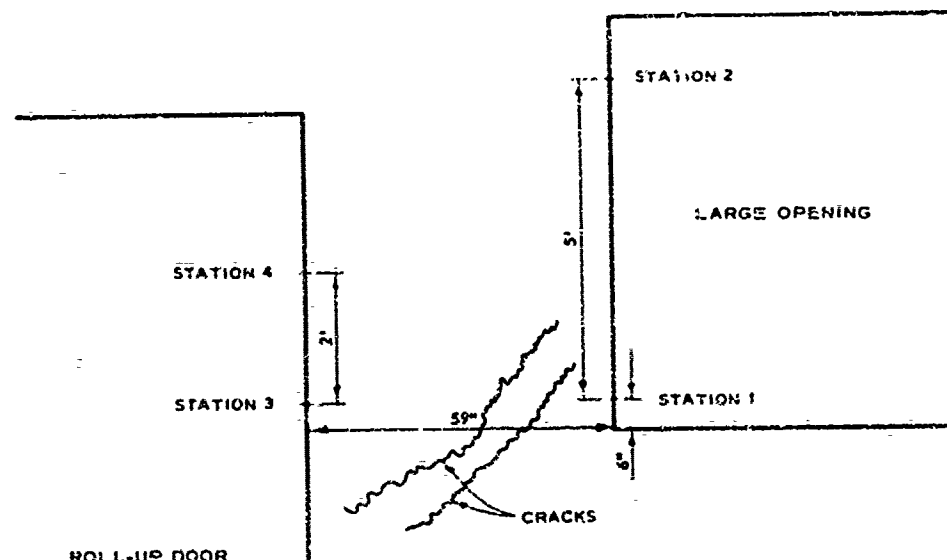
- c. Between roll-up door and large opening. Four readings were taken through the section of wall between the roll-up door and the large opening north of the door (plate 3). Two of these readings, taken through the undamaged area, produced velocities of 14,610 and 14,925 fps. The two readings taken through the cracked area gave velocities of 10,770 and 12,425 fps. Plate 3 shows results of tests in this area.
- d. South end. Thirty-two measurements were made in this area of the west wall (plate 4). Fifteen straight-through readings averaged 14,570 fps. Of the seventeen diagonal readings taken, the six which did not cross cracks averaged 14,835 fps, and the 11 which crossed cracks averaged 14,270 fps. The hairline cracks in this area had very little effect on velocity.

STATION LOCATION AND
PULSE VELOCITY DATA,
WEST WALL BETWEEN
ROLL-UP DOOR AND
LARGE OPENING
ECS BUILDING

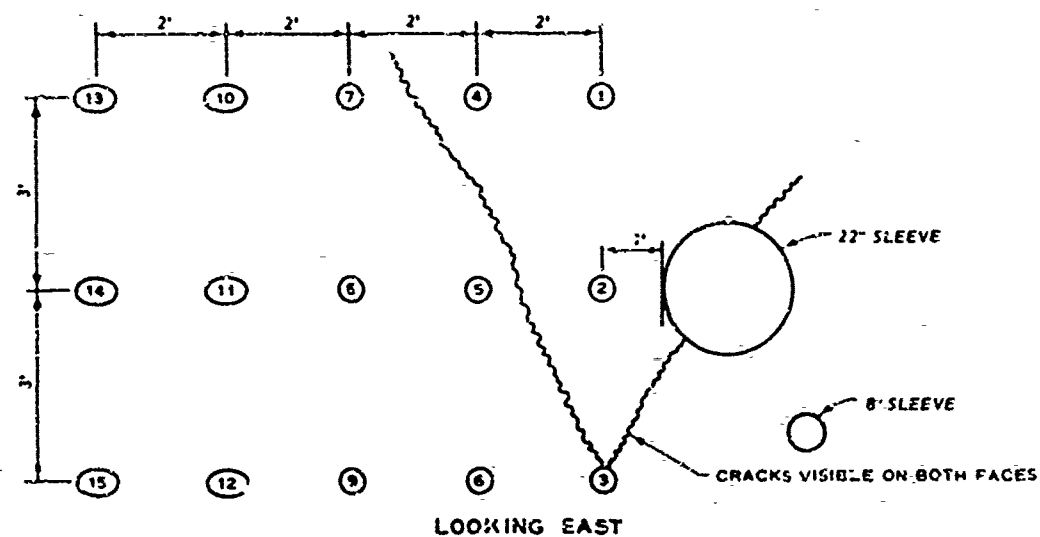
**STATION LOCATION AND
 PULSE VELOCITY DATA,
 SOUTH END OF WEST WALL
 EGS BUILDING**

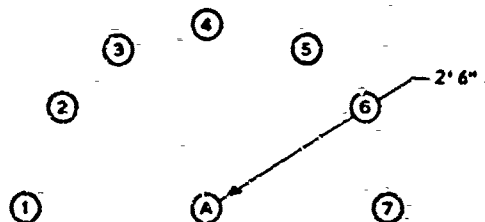
PLATE 5

NOTE: STATION A WAS MARKED ON TOP AND ON UNDERSIDE OF ROOF.
STATIONS 1 THROUGH 7 WERE LOCATED ON UNDERSIDE OF ROOF.
THERE WAS NO VISIBLE DAMAGE IN THIS AREA.

STATION LOCATION AND
PULSE VELOCITY DATA,
STATION A ON ROOF
ECS BUILDING

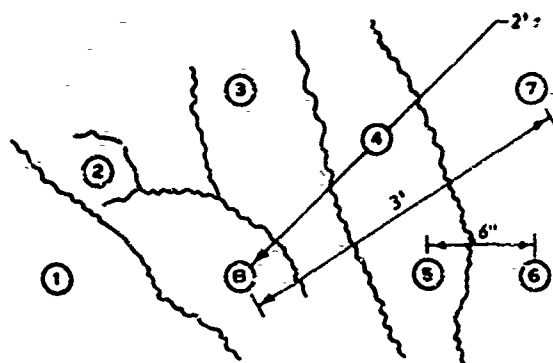
- a. Station B. The roof in the vicinity of station B was cracked in several places (plate 6). The straight-through reading showed a velocity of 16,665 fps. The remaining seven readings produced velocities between 15,285 and 12,415 fps. Lower readings were obtained as the number of cracks in the path of the signal increased.
- b. Station C. There was only one visible crack in the vicinity of station C (plate 7). The four velocities which were significantly lower than the others were apparently affected by this crack. The remaining velocities in this area were uniform, and nothing unusual was indicated.

STATION LOCATION AND
PULSE VELOCITY DATA,
STATION B ON ROOF
ECS BUILDING

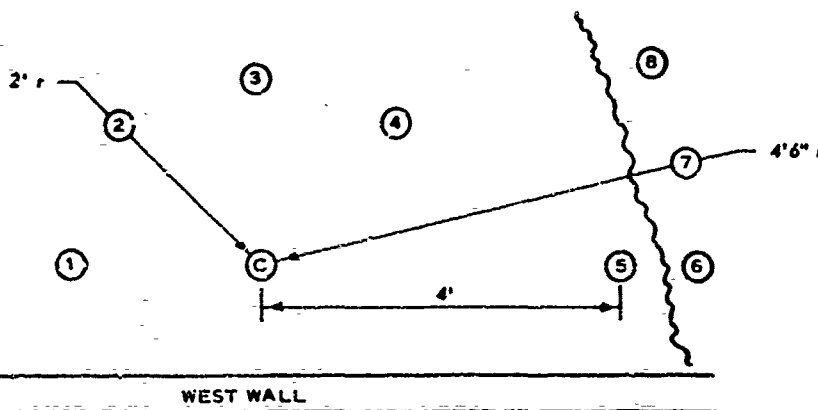
PLATE 7

STATION LOCATION AND
PULSE VELOCITY DATA,
STATION C ON ROOF
ECS BUILDING

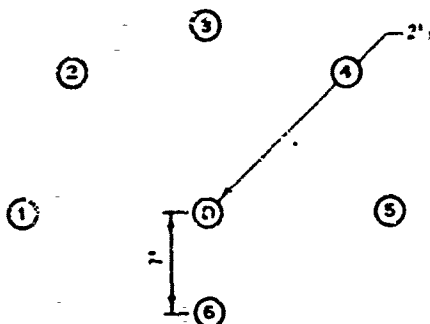
NOTE: STATION D WAS MARKED ON TOP AND ON UNDERSIDE OF THE ROOF.
STATIONS 1 THROUGH 6 WERE LOCATED ON UNDERSIDE OF THE ROOF.
THERE WAS NO VISIBLE DAMAGE IN THIS AREA.

STATION LOCATION AND
FULSE VELOCITY DATA,
STATION D ON ROOF
ECS BUILDING
